# **HALIFAX COUNTY CONDOMINIUM CORPORATION (HCCC) No. 92 RESERVE FUND STUDY (RFS)**

64 Cumberland Drive, Dartmouth, NS

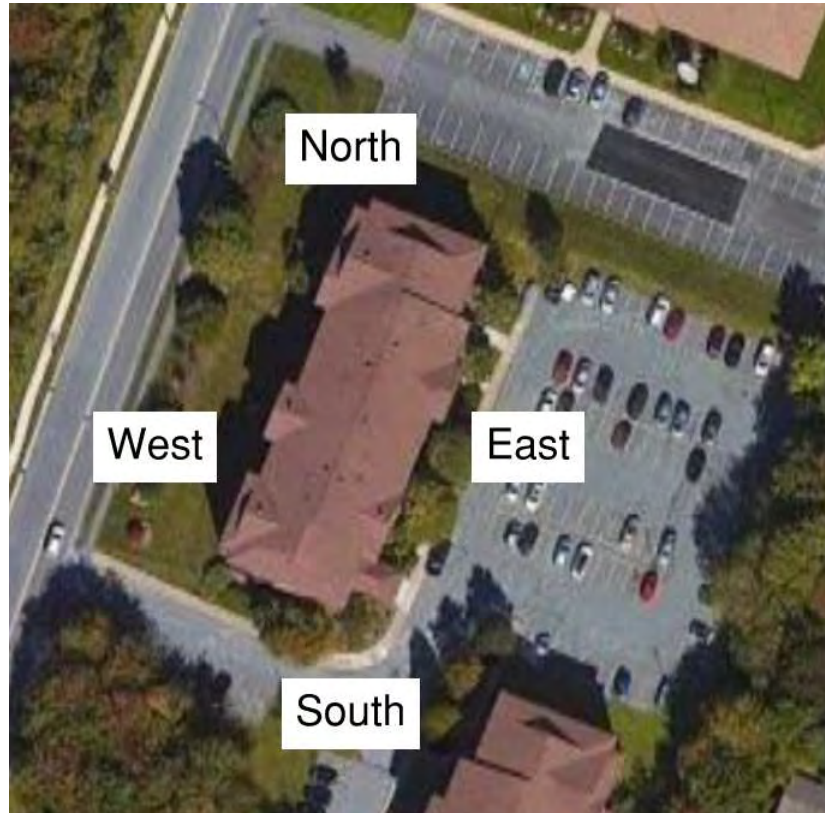
For this report, please refer to this image, as this will serve as the key plan of the report

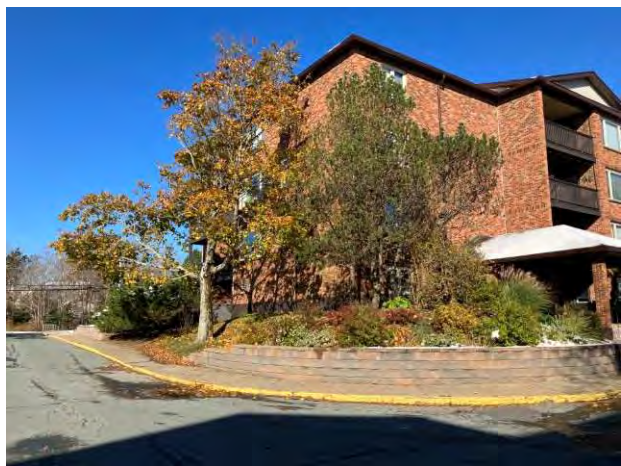
View of typical soft landscaping at southeast corner

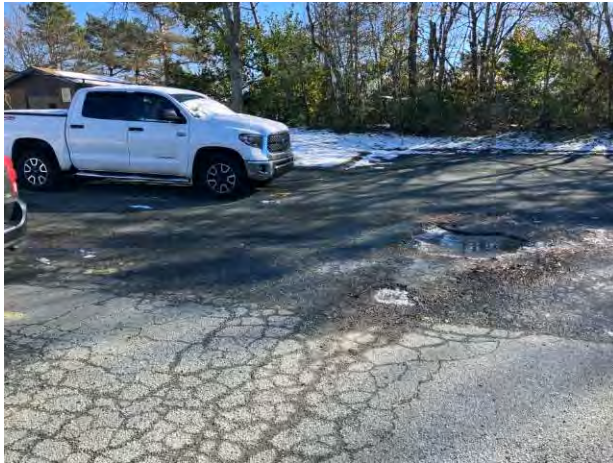
Asphalt parking lot on northeast side of property, with damaged section

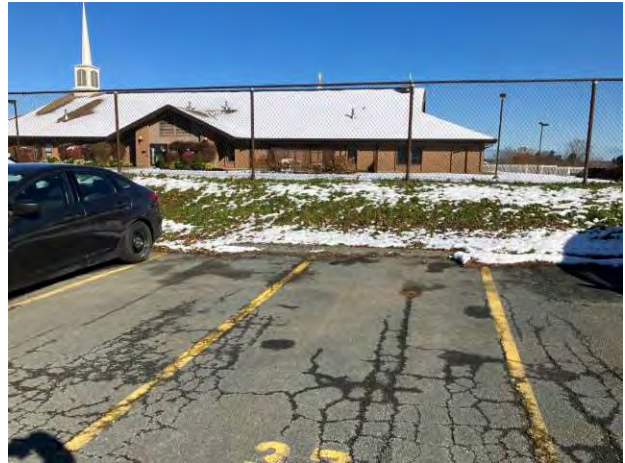
Asphalt parking lot on north side of property

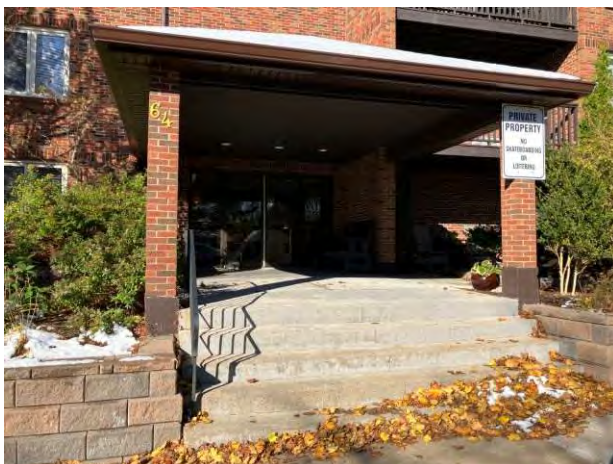
Main entrance concrete slab

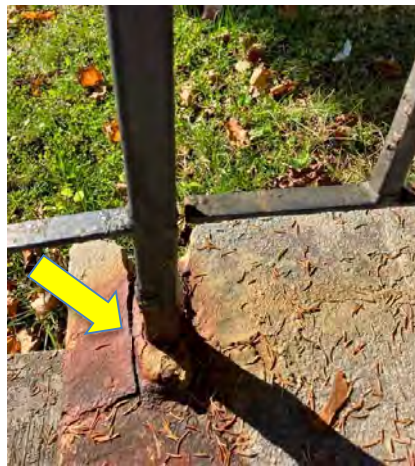
North entrance landing cracks

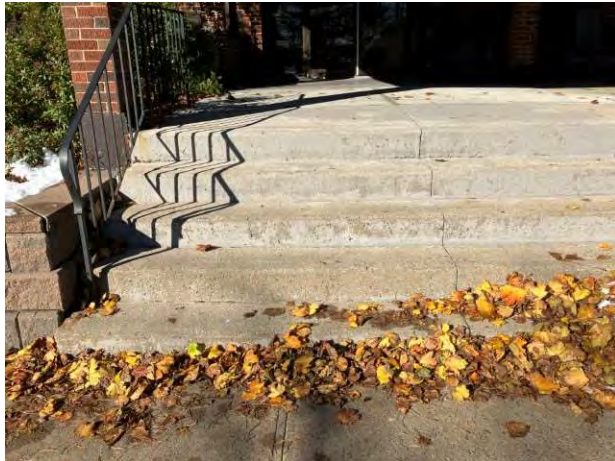
Main entrance metal handrail

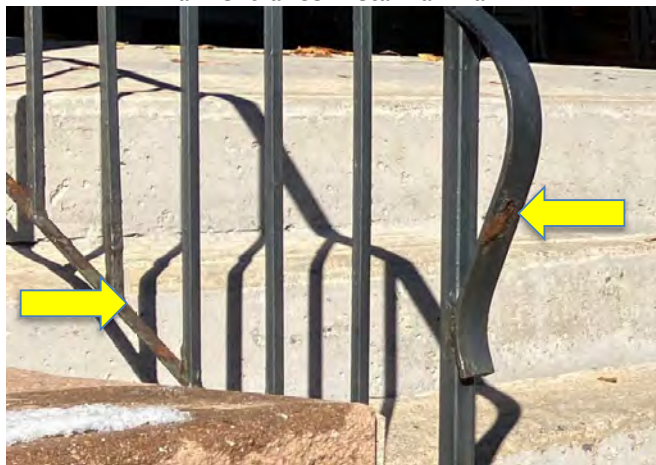
Main entrance metal handrail corrosion

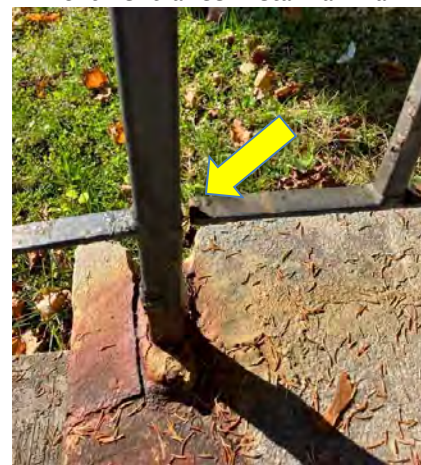
North entrance metal handrail corrosion

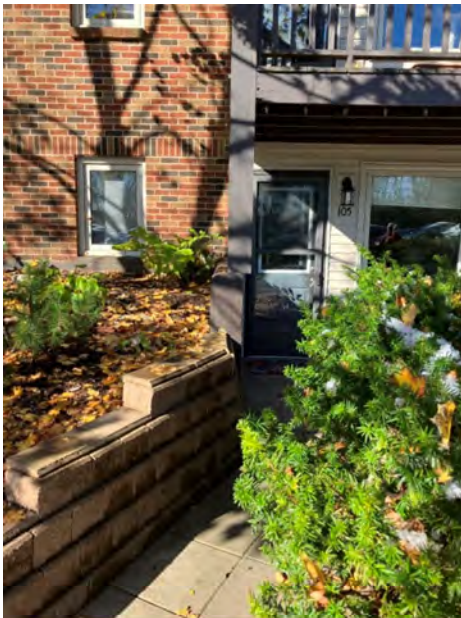
Stone block patio retaining wall at northeast side of property

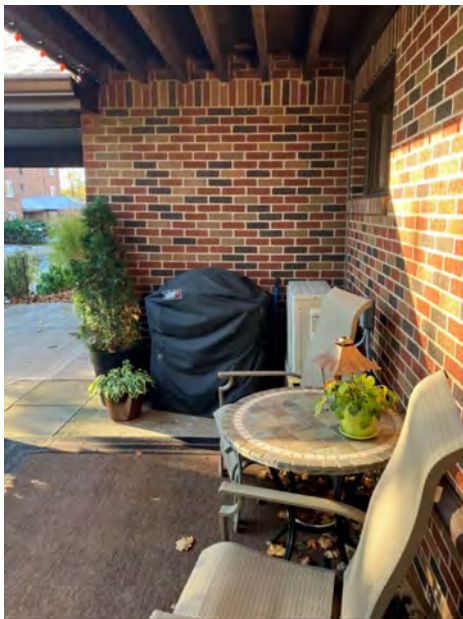
Typical concrete patio at southeast corner

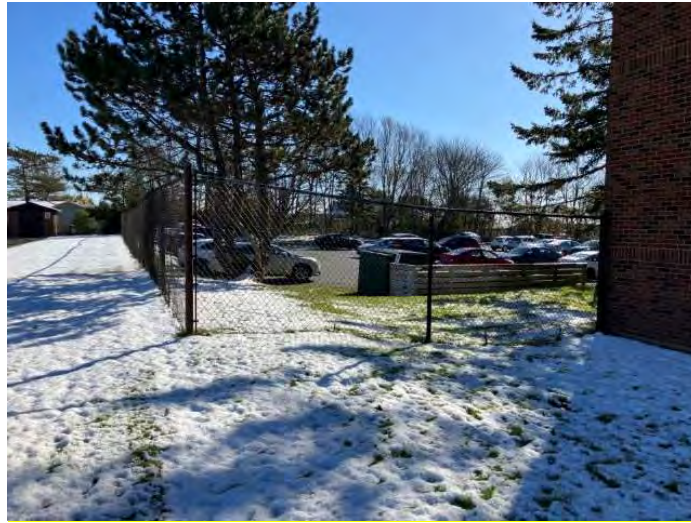
Chain link fencing at north end of property

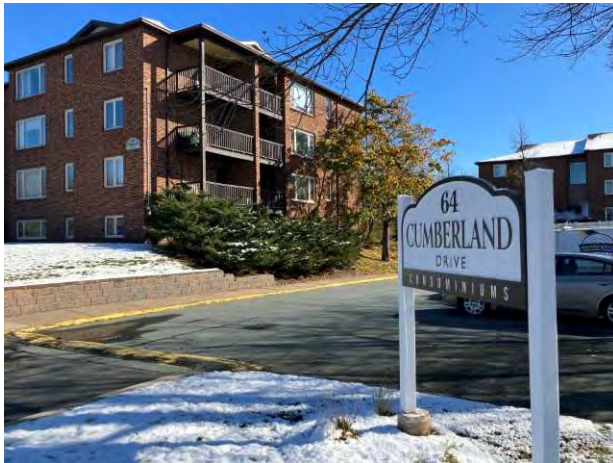
View of recently installed property identification sign

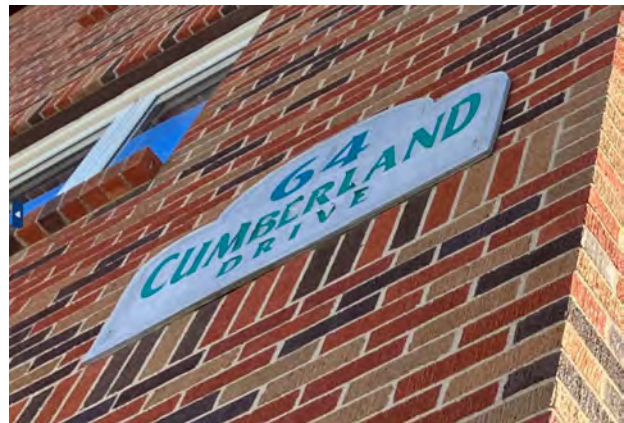
View of existing building unit sign showing signs of wear

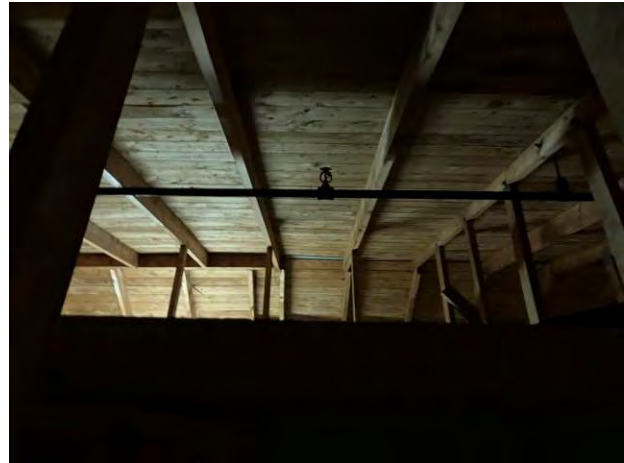
Fire safety system sprinkler head in attic

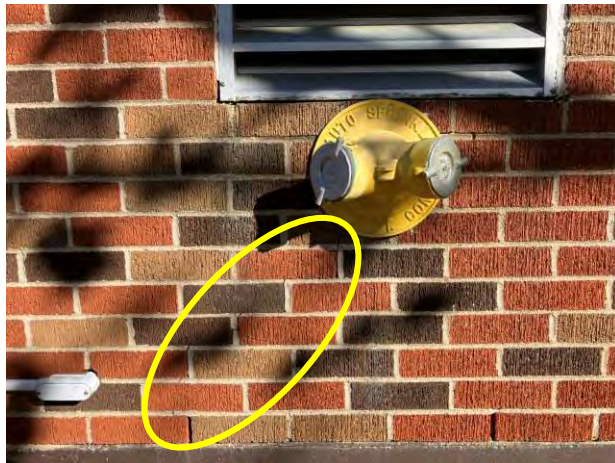
Cracked mortar beneath fire department connection on south elevation

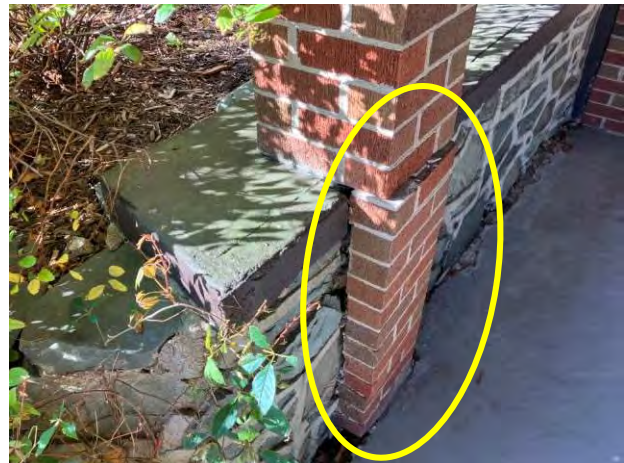
Main entrance brickwork in need of repair

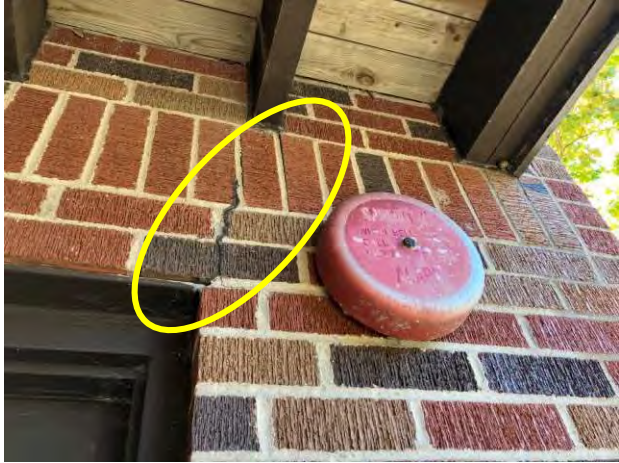
Mortar crack above mechanical room exterior entrance sealed with caulking

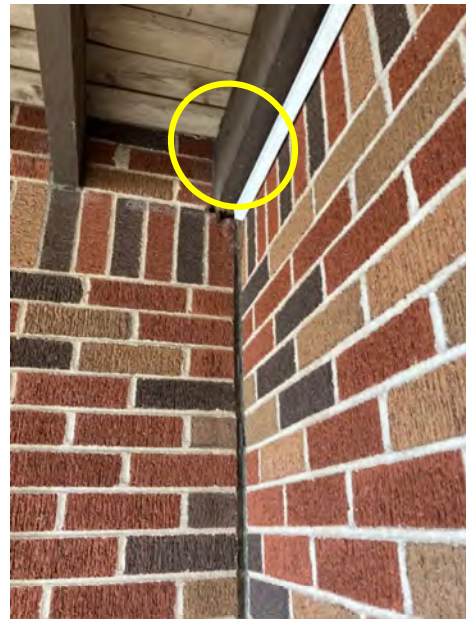
Void in brickwork in mechanical room exterior entrance vestibule

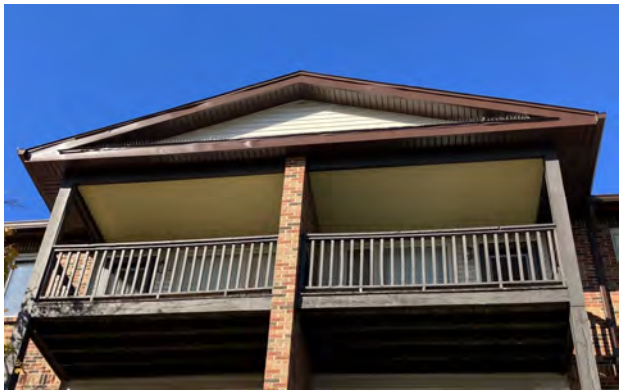
Defects in east elevation fascia above balconies

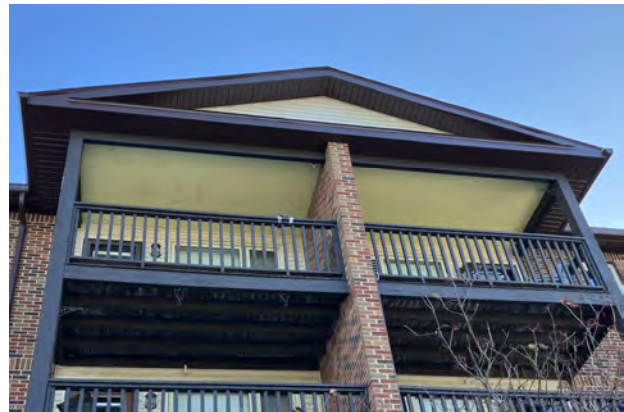
West elevation fascia above balconies

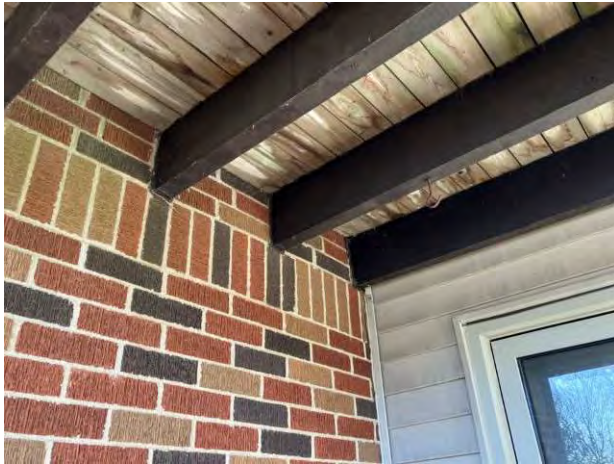
Caulking between brick and wooden floor joists

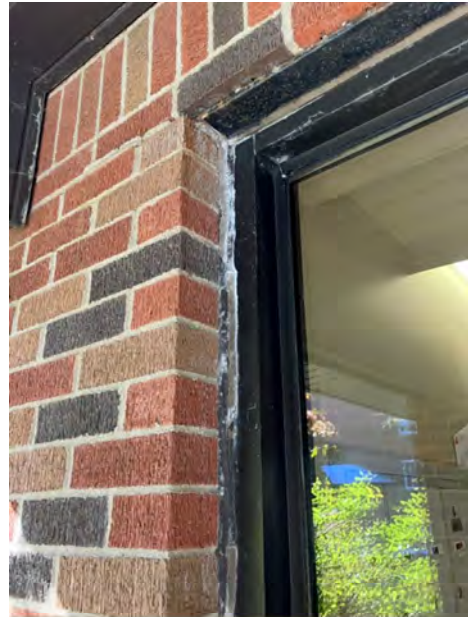
Caulking between main entrance metal door frame and brick veneer showing signs of wear

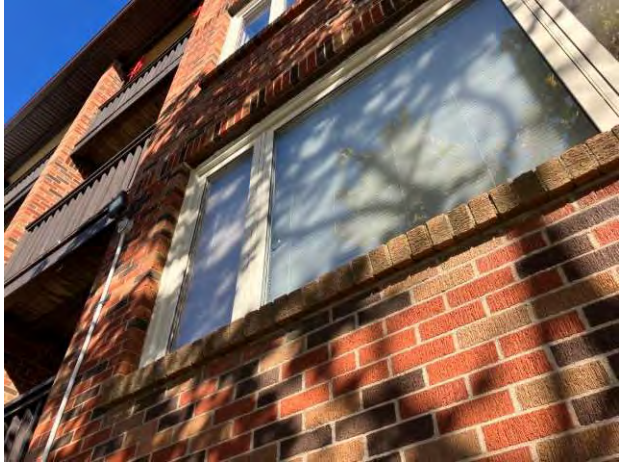
Caulking between brick and vinyl window frame

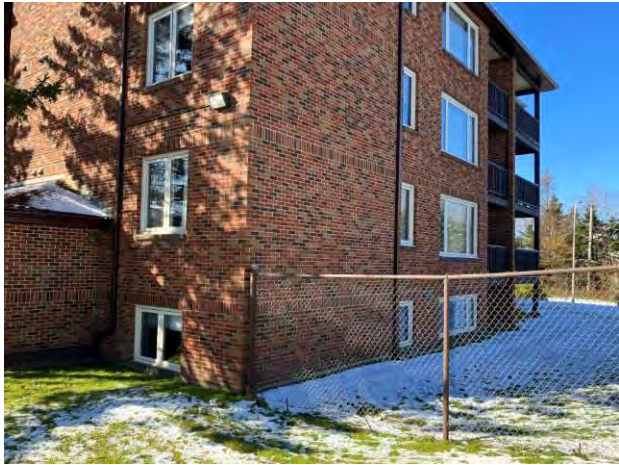
Typical vinyl window types at northeast corner

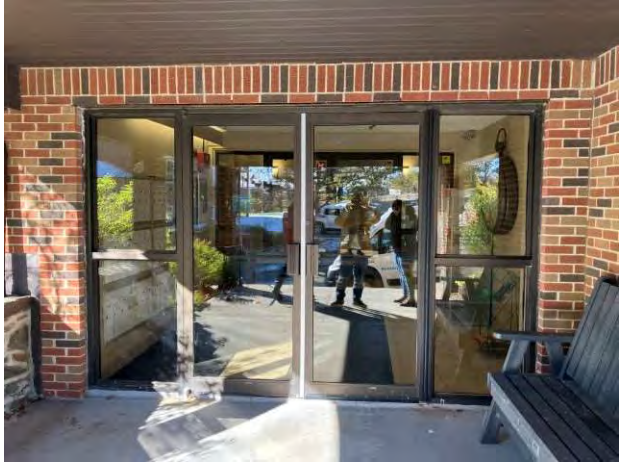
Main entrance aluminum frame doors

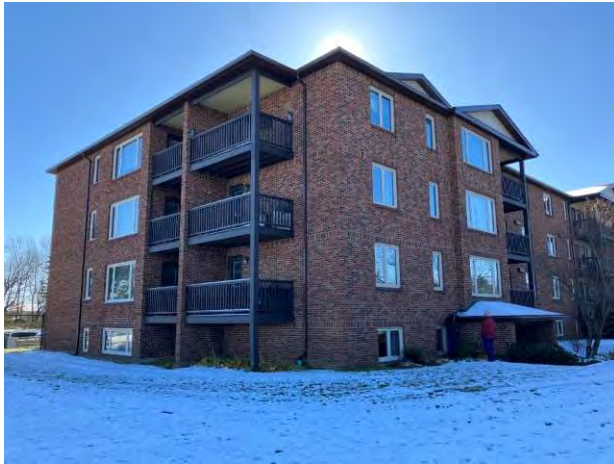
Typical balcony layout on north side of building

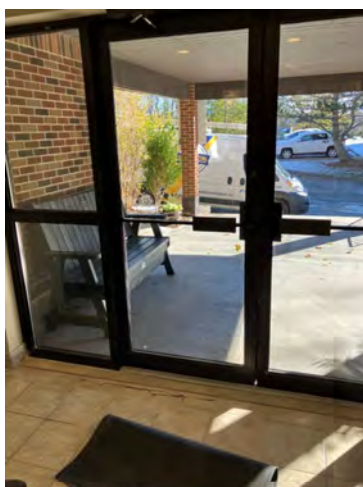
Cracked entrance foyer tiles

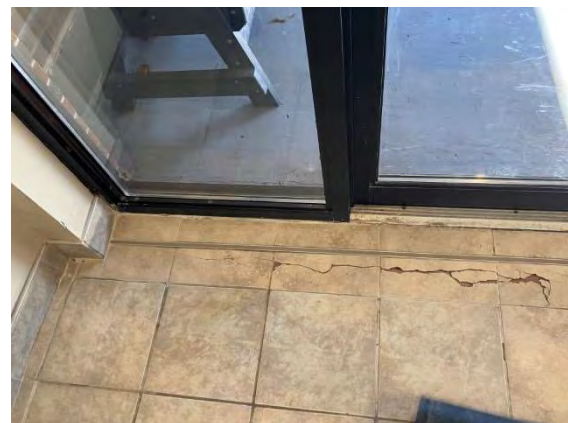
Detail of cracked entrance foyer tiles

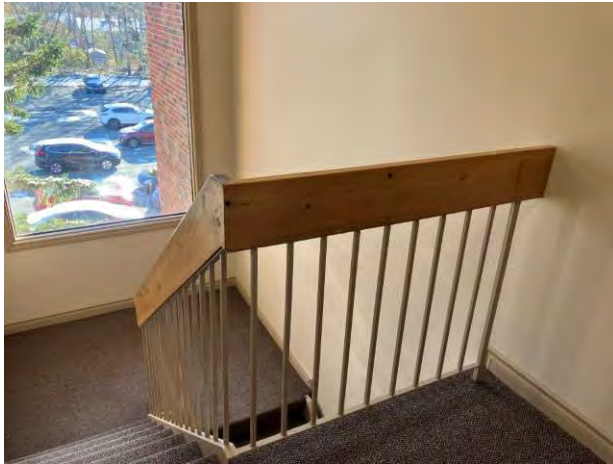
Typical carpeted stairwell with wood handrail

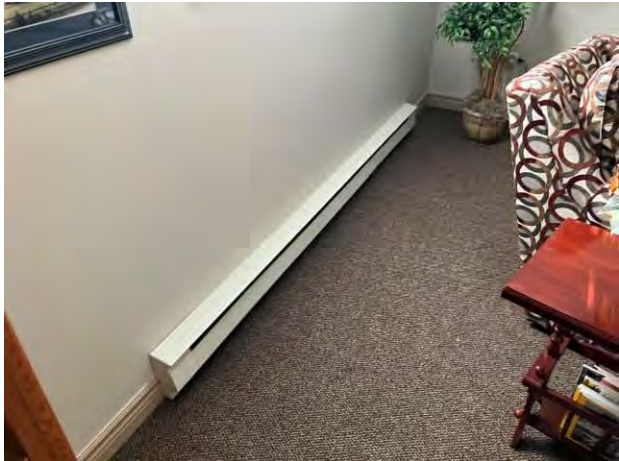
Common room electric baseboard heater

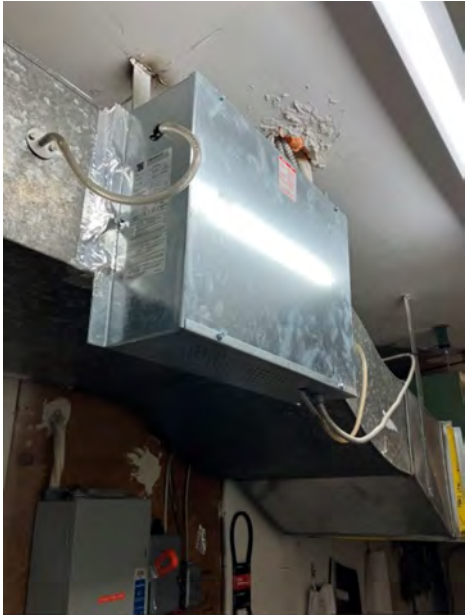
Electric duct heater replaced in 2023

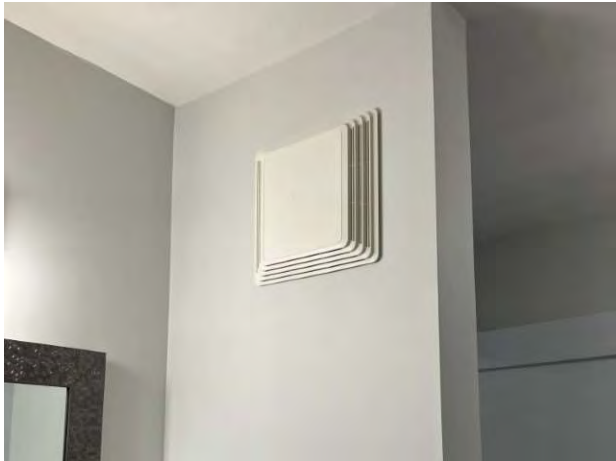
Typical bathroom exhaust fan

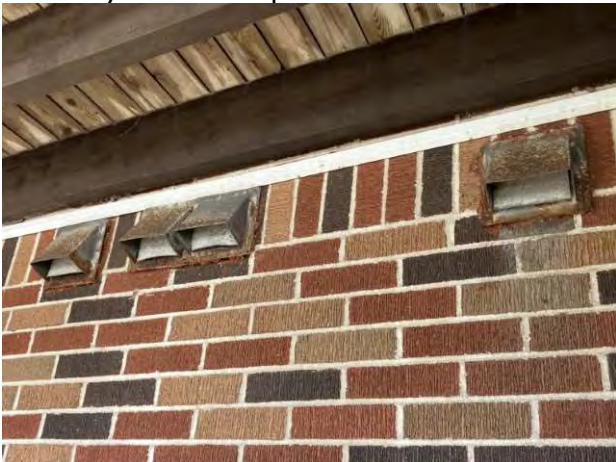
North elevation corroded and poorly sealed exhaust duct hoods

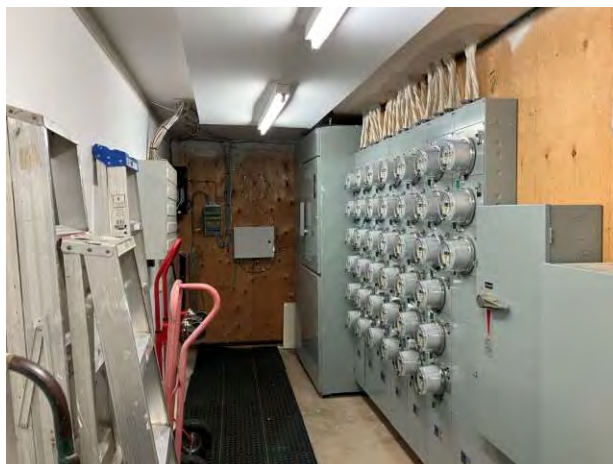
Year	Action	Budget Allowance
2034	Replace Electrical Services	\$ 75,000
2034	Replace Electrical Distribution	\$30,000

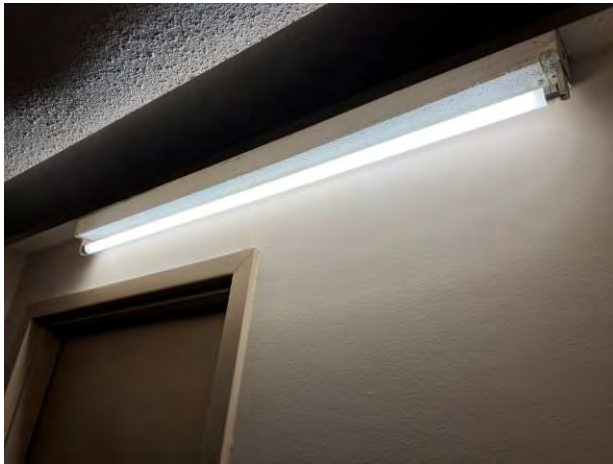
Typical LED corridor lighting

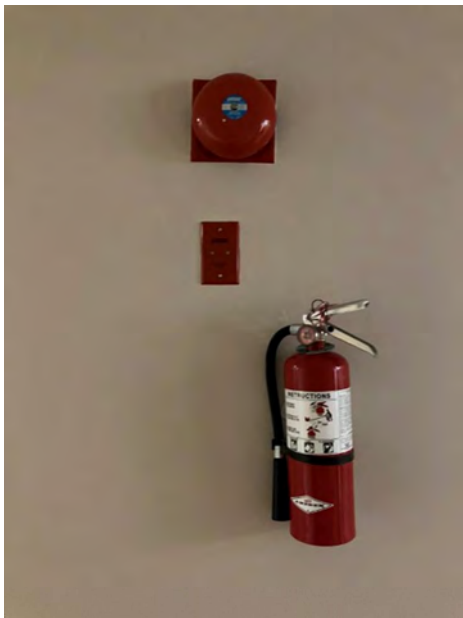
Corridor fire protection equipment
